# High-Risk Notifications: A Heads-Up for Hidden Hazards

### Risks include a wide array of hazardous conditions

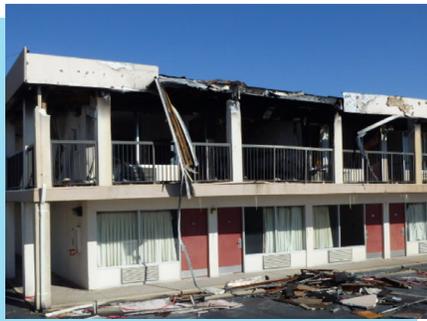
**Discrepancies in occupancy:** Sometimes, a policy or application for insurance coverage will list one type of business, but a field representative will encounter a completely different use on site. An inspection revealed that a building the insurer believed was occupied was actually condemned (pictured at left). An attractive, multistory building listed as manufacturing on the policy was discovered to be vacant when a field rep visited the property. Another visit to a retail store that still had a sign outside revealed empty shelves and abandoned fixtures inside.

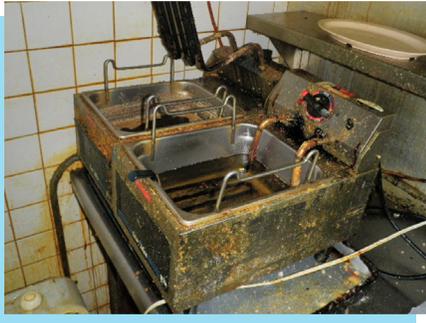
**Commercial cooking:** Excessive grease in hoods, exhausts, ducts, and even light fixtures poses severe fire hazards. Cooking is the top cause of nonresidential property fires, according to the U.S. Fire Administration (USFA),<sup>1</sup> representing 33,200 fires costing \$59.6 million in 2019 alone. The data reflects a 39 percent increase in fires in the most recent 10-year reporting period. Verisk's field reps inspect kitchens to ensure there is no grease hazard on appliances, such as with

the deep fryer pictured at left. They also check for the presence of an automatic extinguisher system (AES) correctly placed over cooking appliances. The lack of an AES in kitchens where a deep fryer or charbroiler is present would prompt an early warning to an insurer. Sometimes reps find that when a restaurant moves in with new equipment, the existing AES and ventilation system are inadequate.

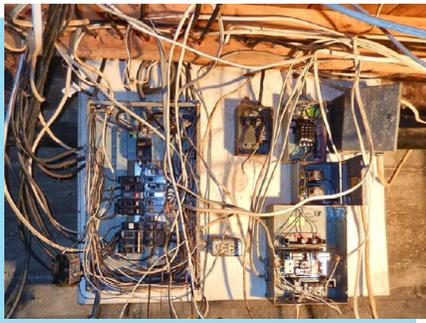
**Electrical systems:** Electrical malfunctions sparked 8,200 fires and cost an estimated \$410.7 million in losses in 2019, according to the NFPA.<sup>2</sup> Verisk's field reps examine breaker panels and wiring to look for such hazards as spliced and exposed wires (shown at left), missing panel doors and spacers, conduits blocking the panel door, and water damage near the electrical panel.

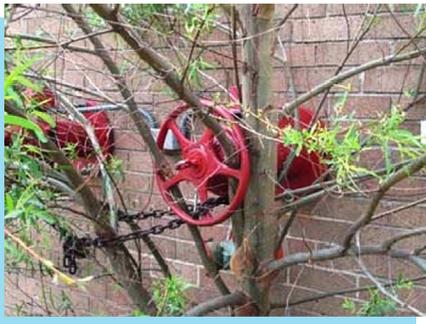
**Fire protection:** Assessing a building's fire safety varies widely by occupancy. A warehouse or other large facility with an automatic sprinkler system is assessed to determine whether the system will be ready to function in the event of a fire, including ensuring all of the valves are in the correct positions and whether regular inspections, testing, and maintenance have been performed. Field reps have encountered water valves in the off position, valves that were not operational because of blockages such as the tree limbs shown here, and other serious deficiencies.

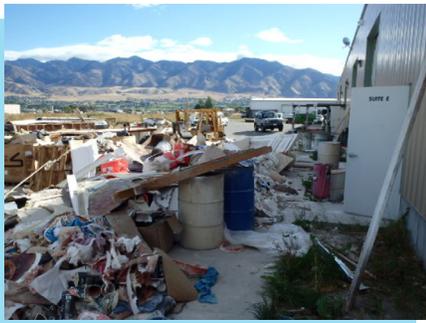
**Housekeeping:** Whether there is lint coating the ceiling beams at a commercial laundry, mounds of sawdust piled up or accumulated on the rafters above sprinkler heads at a woodworking shop, or excessive clutter in general, untidy facilities can trigger a High-Risk Notification. There are fire hazards associated with poor housekeeping as well, such as trip-and-fall and other liability hazards, as seen in this photo at left where the property owner allowed a wide array of debris to accumulate outside.

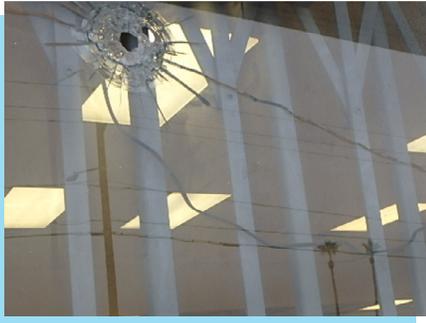
**Surprises:** In addition to the more common water, electrical, and fire hazards, the Survey Services team can spot unusual situations that warrant a High-Risk Notification. For example, representatives have discovered improperly stored weaponry, including a machete in the rear of a retail store and a shotgun leaning on a wall in a convenience store, and evidence of past violence, such as bullet holes in a window (pictured at left). A child taking a nap in an electrical room, an exterior door that opened several feet above the ground, and a hole in a second-floor walkway covered with plywood are among the notable hazards the Survey Services team has encountered.

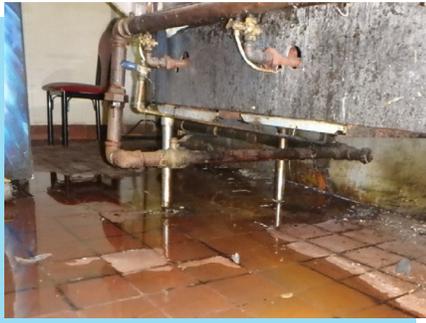
**Water:** Evidence of sewers backing up in commercial kitchens, roof damage, and leaking pipes are among the signs field reps look for to spot water damage.
