MECKLENBURG COUNTY
RISK ID: 32 NC99 040	235	ON-SITE SURVEY: 4/1/2009	LAST UPDATE: 4/1/2009

SUMMARY

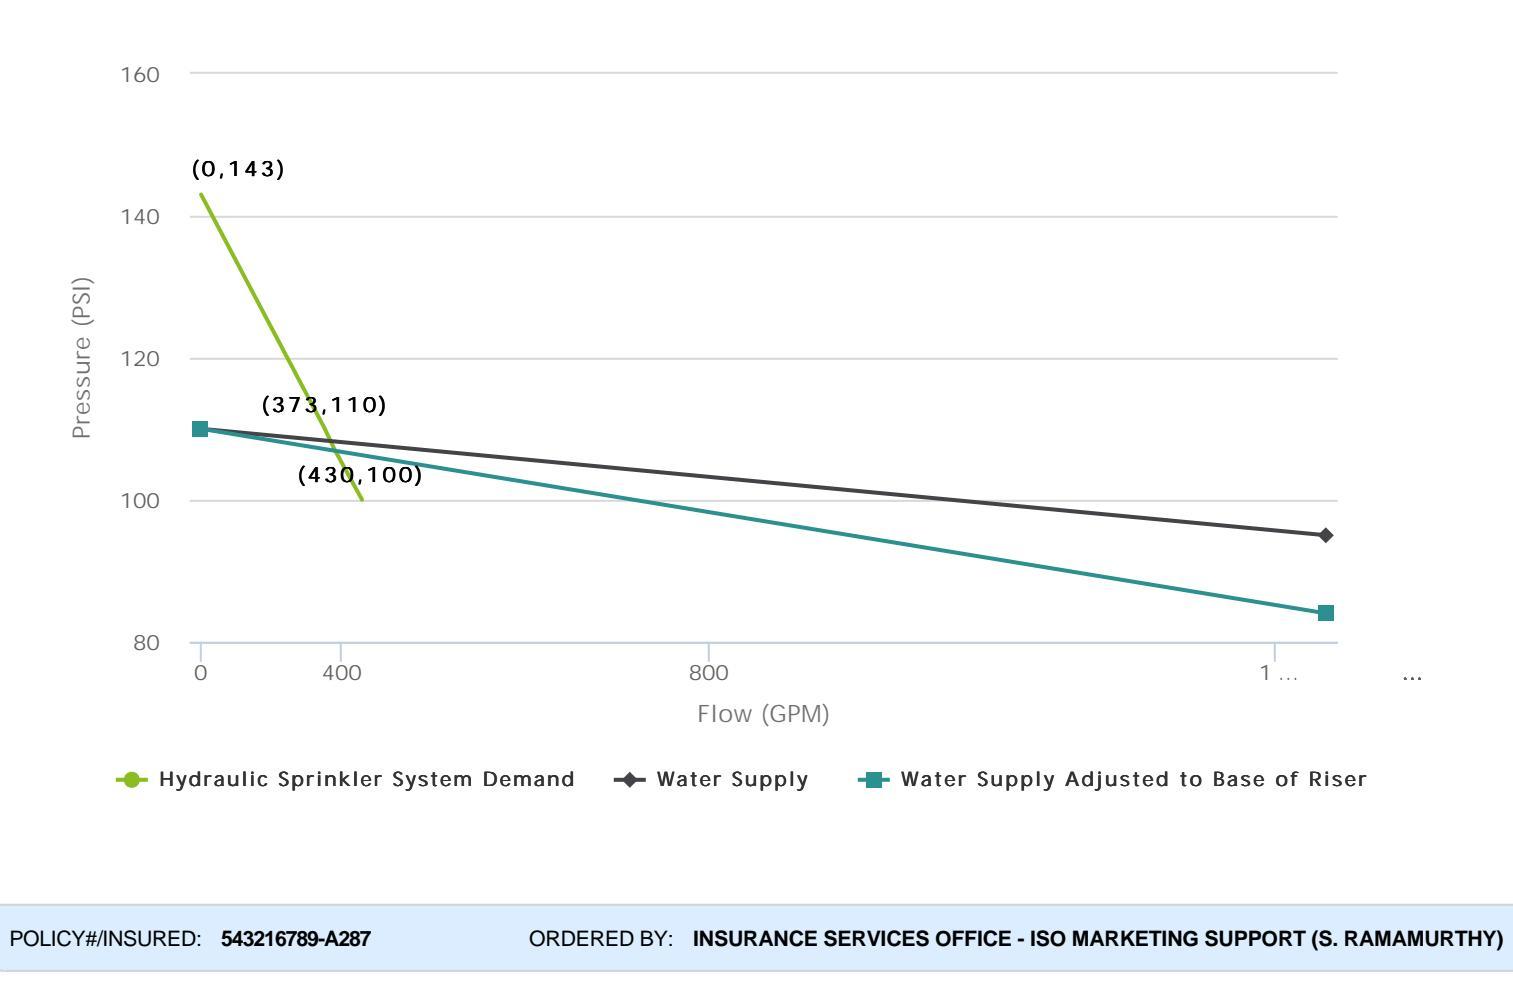
HYDRAULIC GRAPH

Water Supp	ly Deficiency Ev	aluation					
Supply Source	Flow at Intersection (GPM)	Pressure at Intersection (PSI)	Storage Deficiency Percent	Deficient Storage Adjustment Factor	Deficient Pressure Adjustment Factor	Water Supply Deficiency Percentage	Points
Supply Source 1	389	107	N/A	1	1	9	6
System with v	worst demand:			Hydraulic			
Primary Wate	r Supply Source	:		1

Hydraulic graph is a graphical comparison of the available water supply and sprinkler system demand, which also displays the key variables used in the water supply assessment.
